An evaluation of Texas roads provided surprising results when the best friction numbers came from a 10-year-old microsurfacing project. So when TxDOT had a new project that involved maximizing friction on a high traffic road (I-10 in Crockett County) they chose microsurfacing because it can yield greater long-term friction results throughout its service than an ultra thin lift overlay, and at a lower cost.

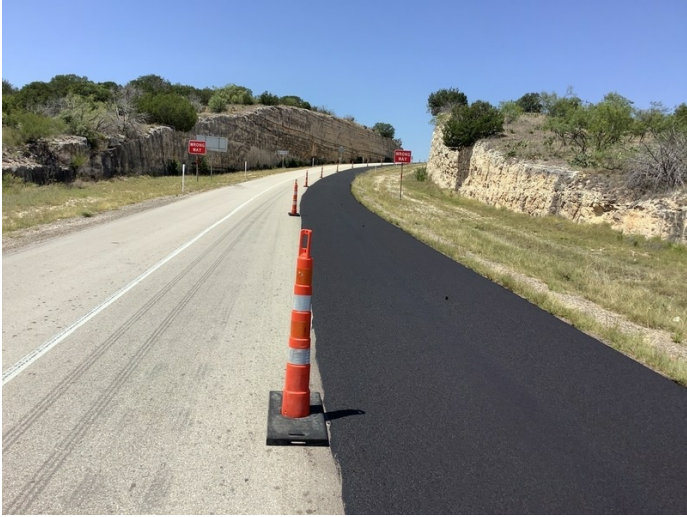
Micro Surfacing is being applied to Interstate I-10 in Ozona, Texas.

On August 3, 2020, the contractor began the process of applying the micro surfacing solution, at 22 pounds per square yard along the 96 lane mile stretch of I-10. Exit and entrance ramps throughout the project also received micro surfacing. The treatment was applied in two-mile increments, with traffic shifted to one lane during application. The fog seal was applied on the shoulders at 0.10 gallons per square yard. Section by section, both treatments cured in less than an hour, at which time traffic was returned. The entire project was completed by September 1.

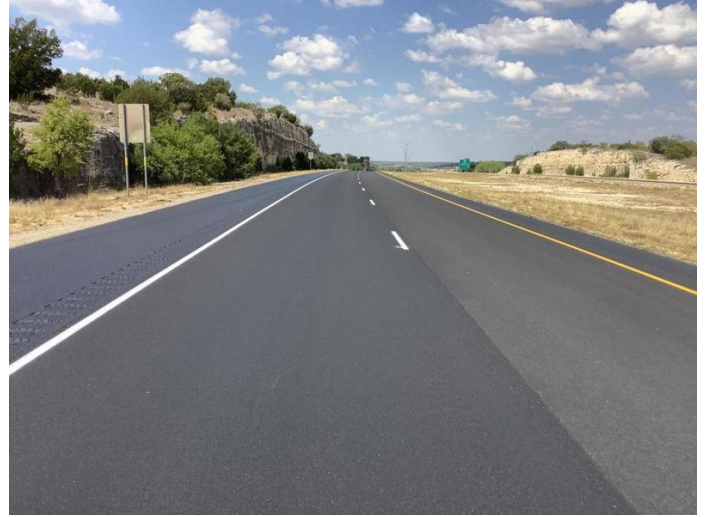
Completed Micro Surfacing project in Ozona, Texas maximized surface friction.
