Cold Central Plant Recycling allowed INDOT to repair and upgrade a major collector in Northeast Indiana. State Route 101 appeared to need surface repairs, but upon further investigation, a deeper treatment was needed in order to restore the roadway and create a safer route for both the local Amish traffic and regular vehicular traffic.

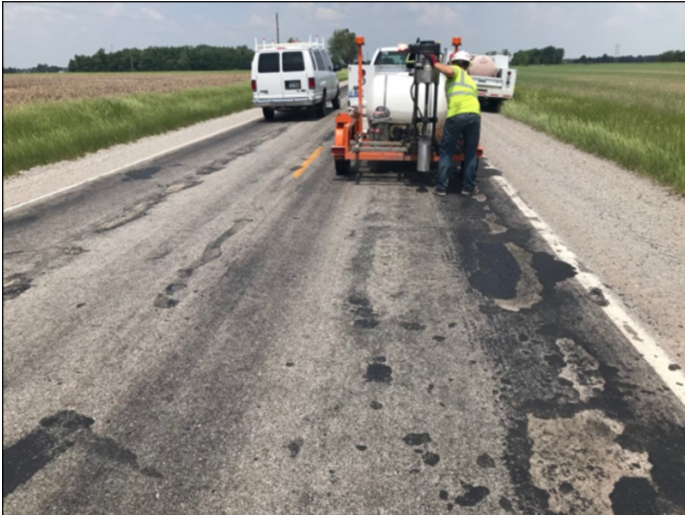
Existing Pavement Surface during Investigative Sampling

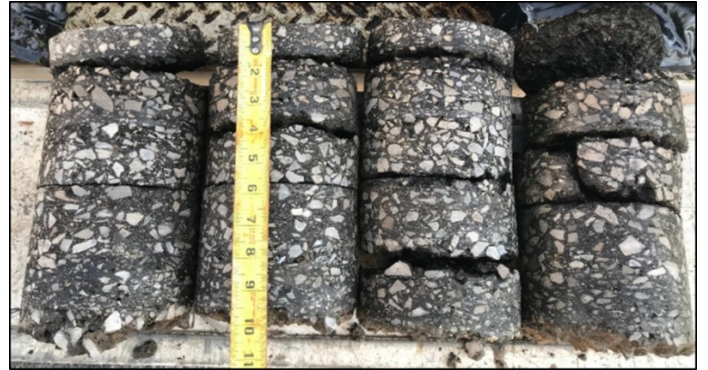
Pavement sampling revealed bottom-up cracking beginning to propagate to the surface. Delaminated, unbound layers, asphalt stripping, and cracked underlying layers were also observed during sampling. INDOT then performed FWD testing on SR 101 to calculate stiffness-related parameters of the pavement structure. It was discovered that there was also poor subgrade strength below the asphalt pavement. These findings revealed that the project was beyond the point where a single lift HMA overlay would be cost-effective.

Pavement Samples taken during Investigative Sampling

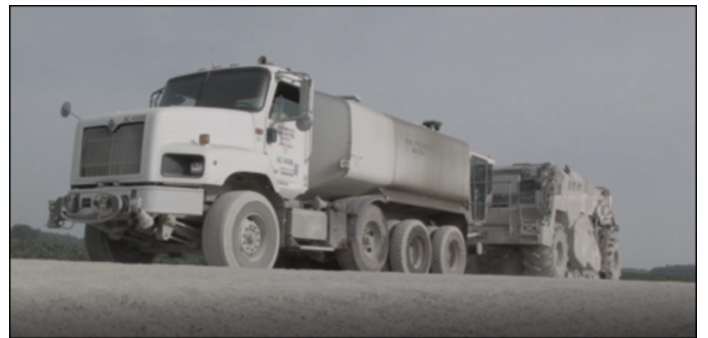
10.0-inch Cement FDR process

INDOT's research led to the solution of placing a Cold Central Plant Recycling (CCPR) treatment on top of a Cement FDR. The project began by milling off the top 8.0-inches of existing asphalt and stockpiling the asphalt millings nearby at a central location. Then the cement FDR was performed on the remaining existing asphalt and the existing base and subgrade to a final depth of 10.0-inches and to a final width of 26 feet.

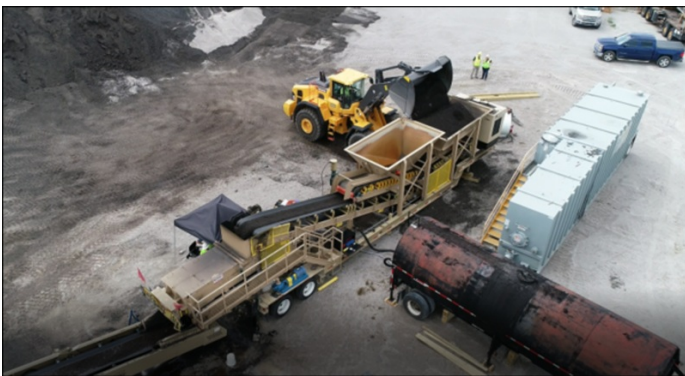
The nearby cold central plant being fed with RAP from the stockpile

The CCPR mix was produced utilizing engineered emulsion and the road's stockpiled asphalt millings at the central location, then loaded onto trucks and hauled back to the roadway where the mix was paved to a depth of 6.0 inches. 37,000 tons of CCPR mix was produced at a rate of 300 tons per hour and the paving of the CCPR mix took 16 days. Once the construction and the curing of the paved CCPR mix were completed, the roadway was profile milled and then a 2.0-inch 12.5mm Surface Mix was placed.

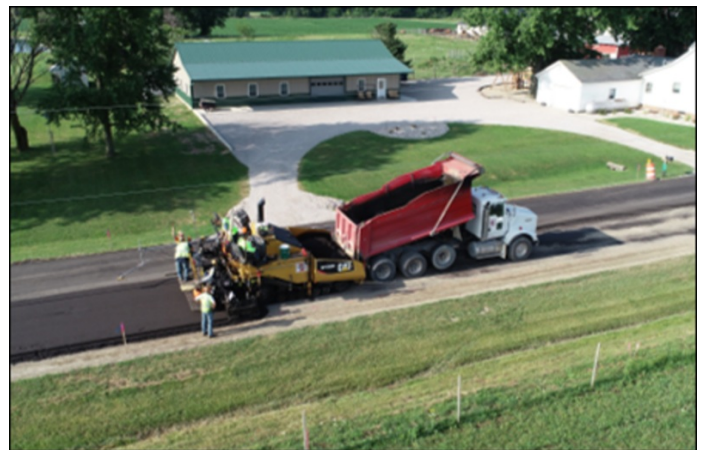
Paving of the 6.0-inch CCPR lift

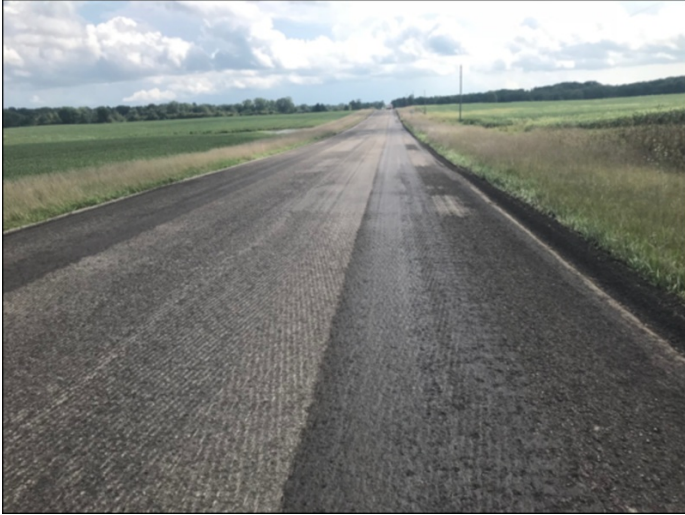
CCPR Mat after Profile Milling

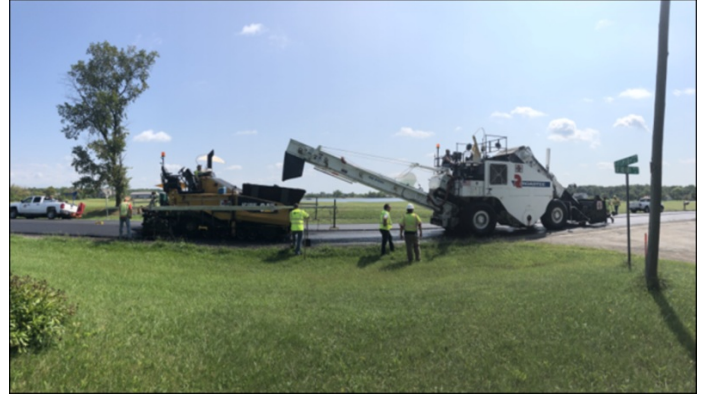
Paving of the 2.0-inch 12.5mm HMA surface

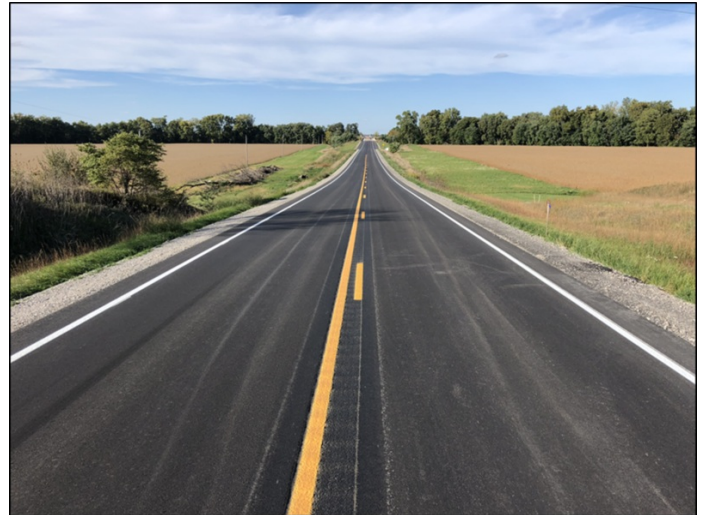
Final Pavement Surface
