In 2005, Mississippi DOT preserved one of their most heavily trafficked highways, adding 14+ years of life while addressing friction, cracking and rutting-- Today in 2020, the highway has required no further treatments.

In 2005, 12 miles of Highway 61 in Tunica, Mississippi needed reprofiling and preservation due to high traffic (13,000 vehicles per day) leading in and out of their gambling district, the third largest in America.

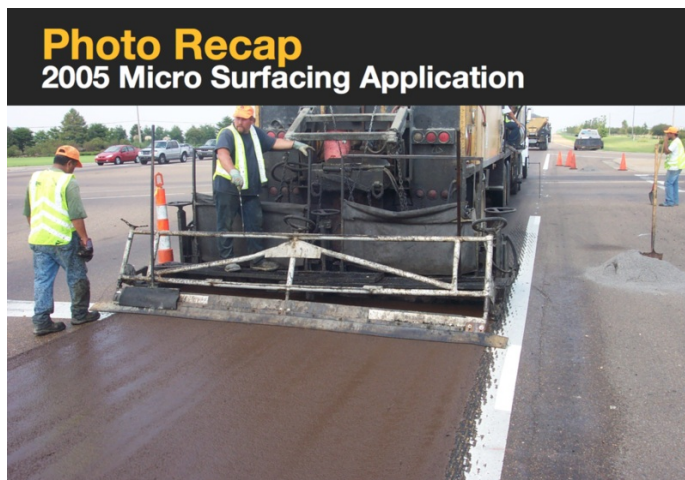
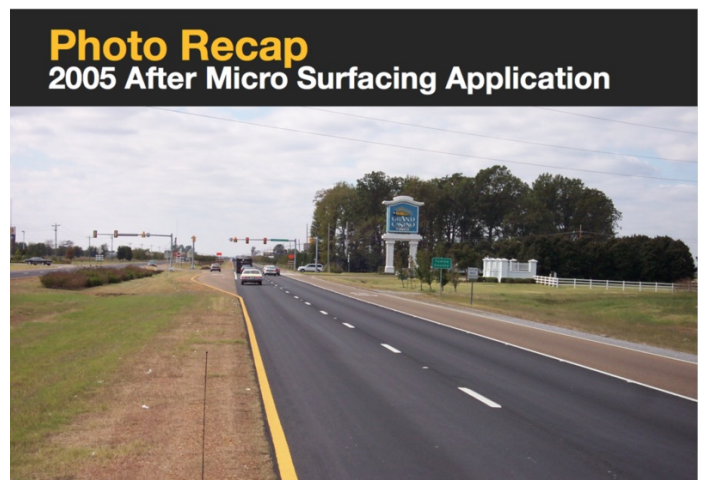
**Photo Recap**  
2005 After Micro Surfacing Application

MDOT worked with Vance Brothers, Ergon Asphalt & Emulsions, and Vulcan Materials Company through devastating weather conditions resulting from hurricane Katrina, to apply micro surfacing in two thin lifts with Type V aggregate and a micro surfacing emulsion (CSS-1HP), applied at 11.0% +/- 1.0%. The optimum emulsion content was engineered to sit on the lower side of the specified range to address rutting.

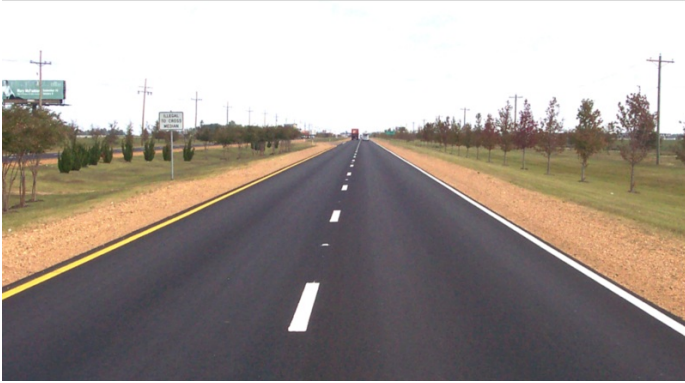
**Photo Recap**  
2005 / 2017 Side-by-Side Comparison

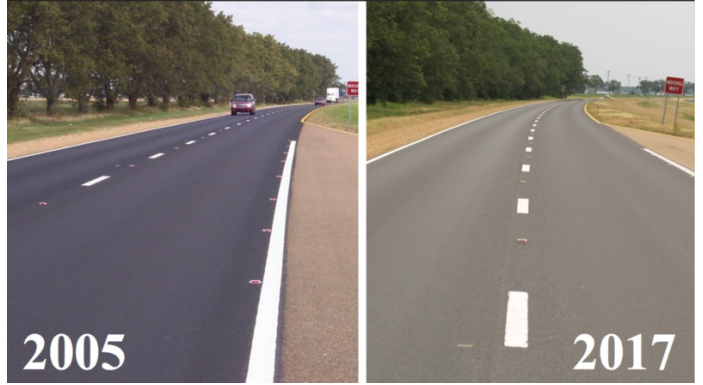
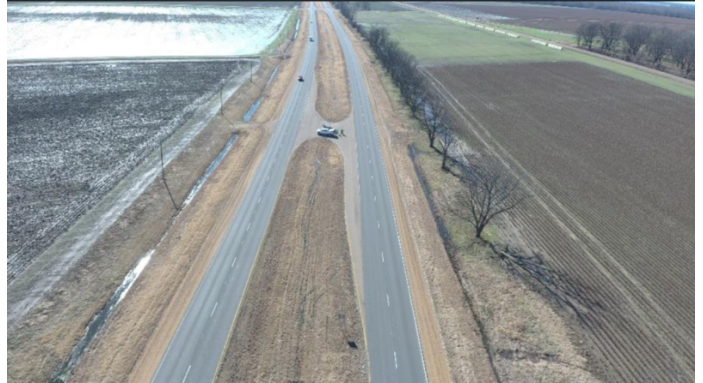
**Photo Recap**  
2020 – Over 14 Years Post Application

This process saved millions of dollars which could be allocated to other needs. Passengers have enjoyed a more durable wearing course which is able to withstand the heavy volumes of traffic. After 14 years the roads continue to hold, requiring no further treatments to date.
