Contractor successfully repaired Lake Louise Marie Road in the Town of Thompson located in Sullivan County New York. Fiber reinforced interlayer with a Paver Placed Surface Treatment overlay.

Town of Thompson , Sullivan County New York , heavy traffic load with predominantly semi tractor trailer vehicle loads.

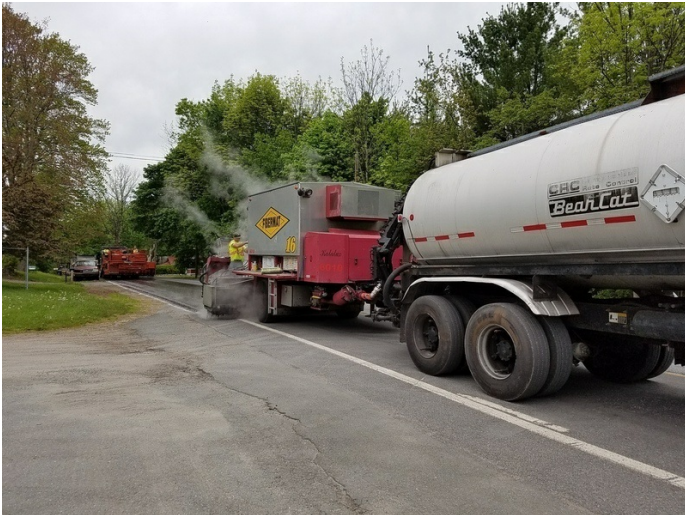
The Gorman Group laying interlayer fiber reinforced system

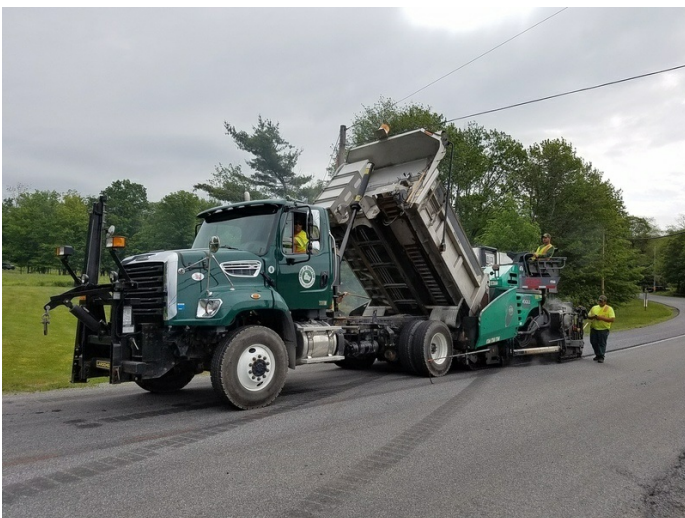
The Gorman Group paving with PPST Type B, utilizing the Town of Thompson to haul material

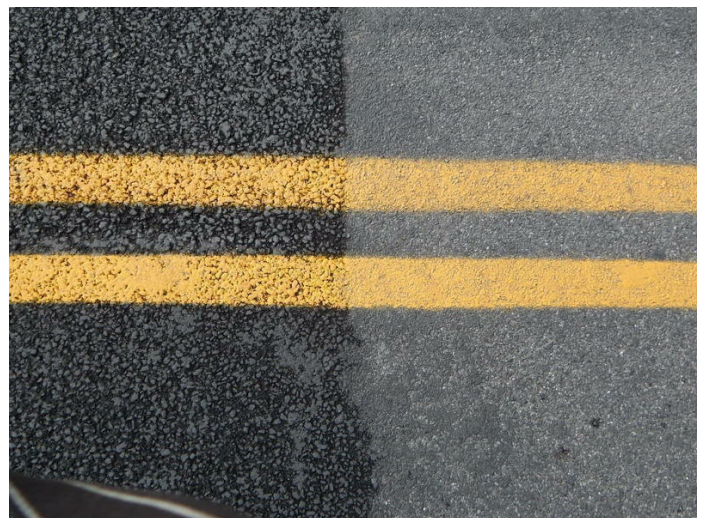
Finished Surface comparison - fiber reinforced interlayer with chip finish on right / PPST Overlay Finish on left
